Limited Visual Dam Safety Inspection Summary Report

MA-068

Reservoir 14

Limited Visual Dam Safety Inspection Conducted on: 05 April 2006

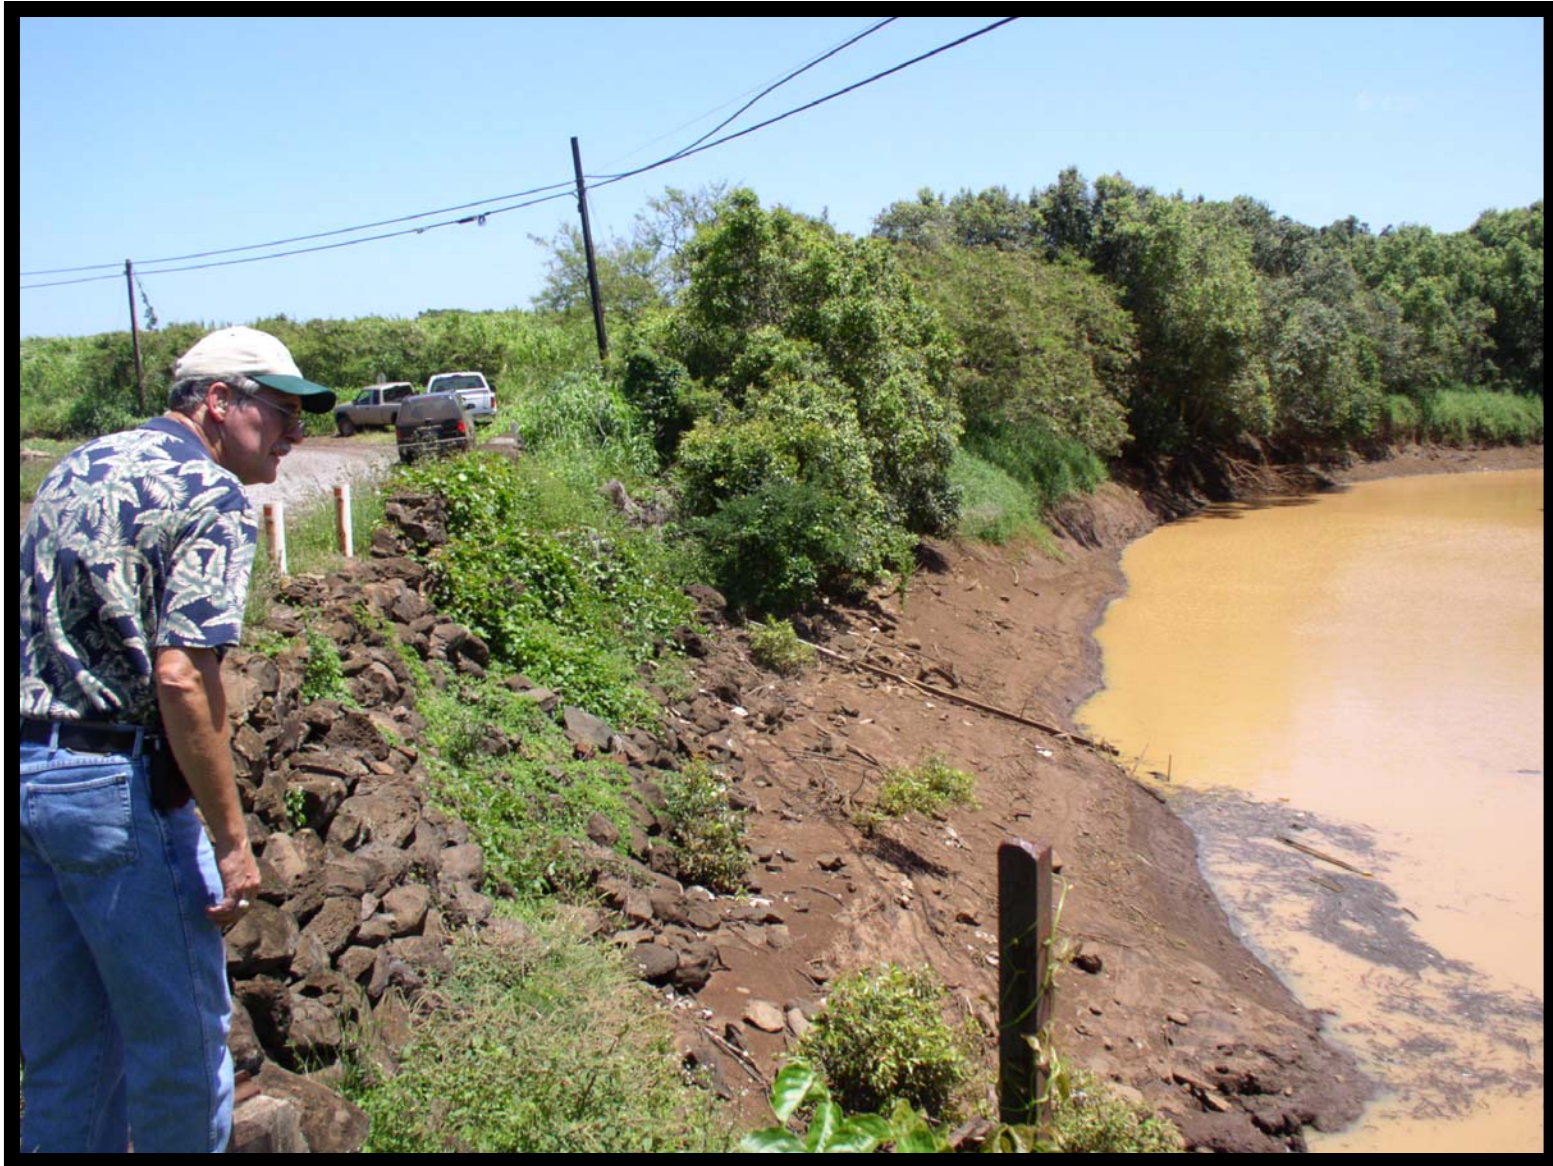
- a. The upstream slope appeared to be in fair to poor condition and requires corrective action.
- b. Slope protection needs maintenance. Description: Need to remove trees and other vegetation from the upstream slope.

- d. Trees were observed on the dam embankment. Trees have been identified as the probable cause of piping failures and can possibly cause severe damage to the embankment if they are uprooted during high winds. Corrective action is required to remove tree hazards from the dam. Acceptable remedies include removal of the tree and its root structure down to a 2-inch diameter and reconstructing the damaged embankment section. All repair work shall be accomplished as per the requirements of licensed geotechnical or structural engineers. Routinely monitor the damaged area for signs of settlement and seepage.

068 Upslope - Note the grouted riprap slope and the large trees at the rear.

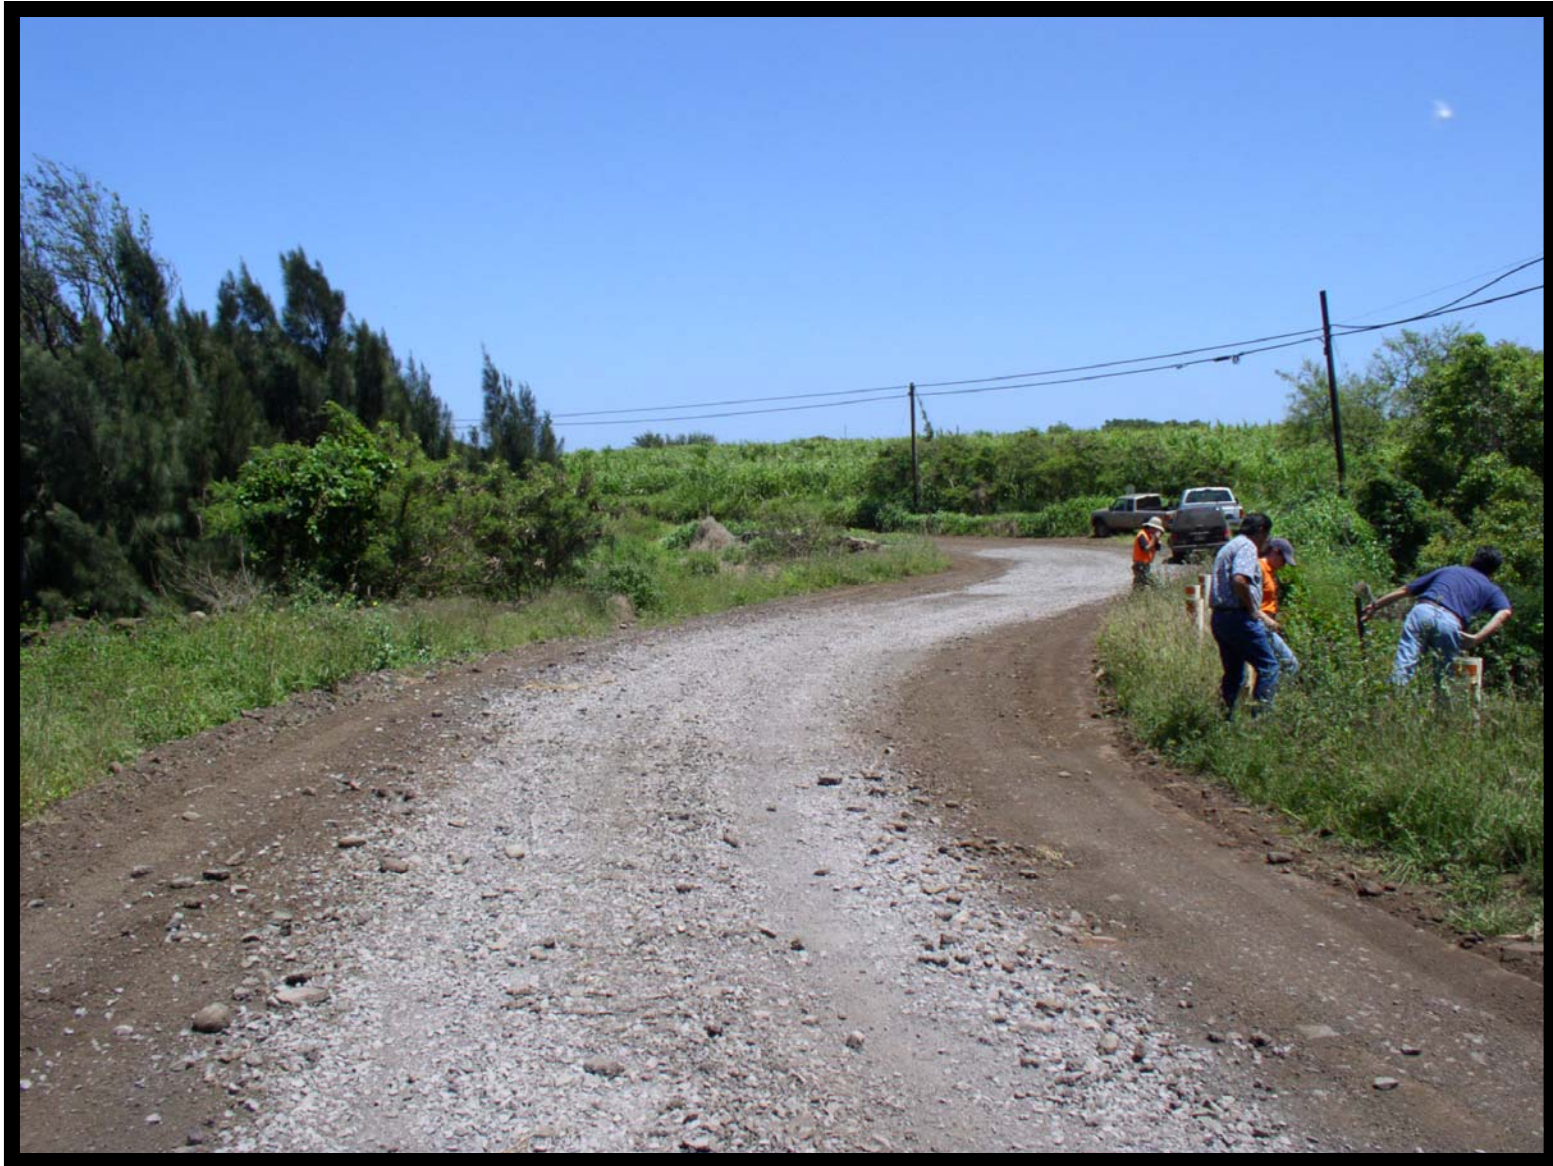
- a. The dam crest appeared to be in satisfactory condition, no corrective actions are required at this time.
- b. Access along the crest was satisfactory.

068 Crest - Note that the crest is also a county highway.

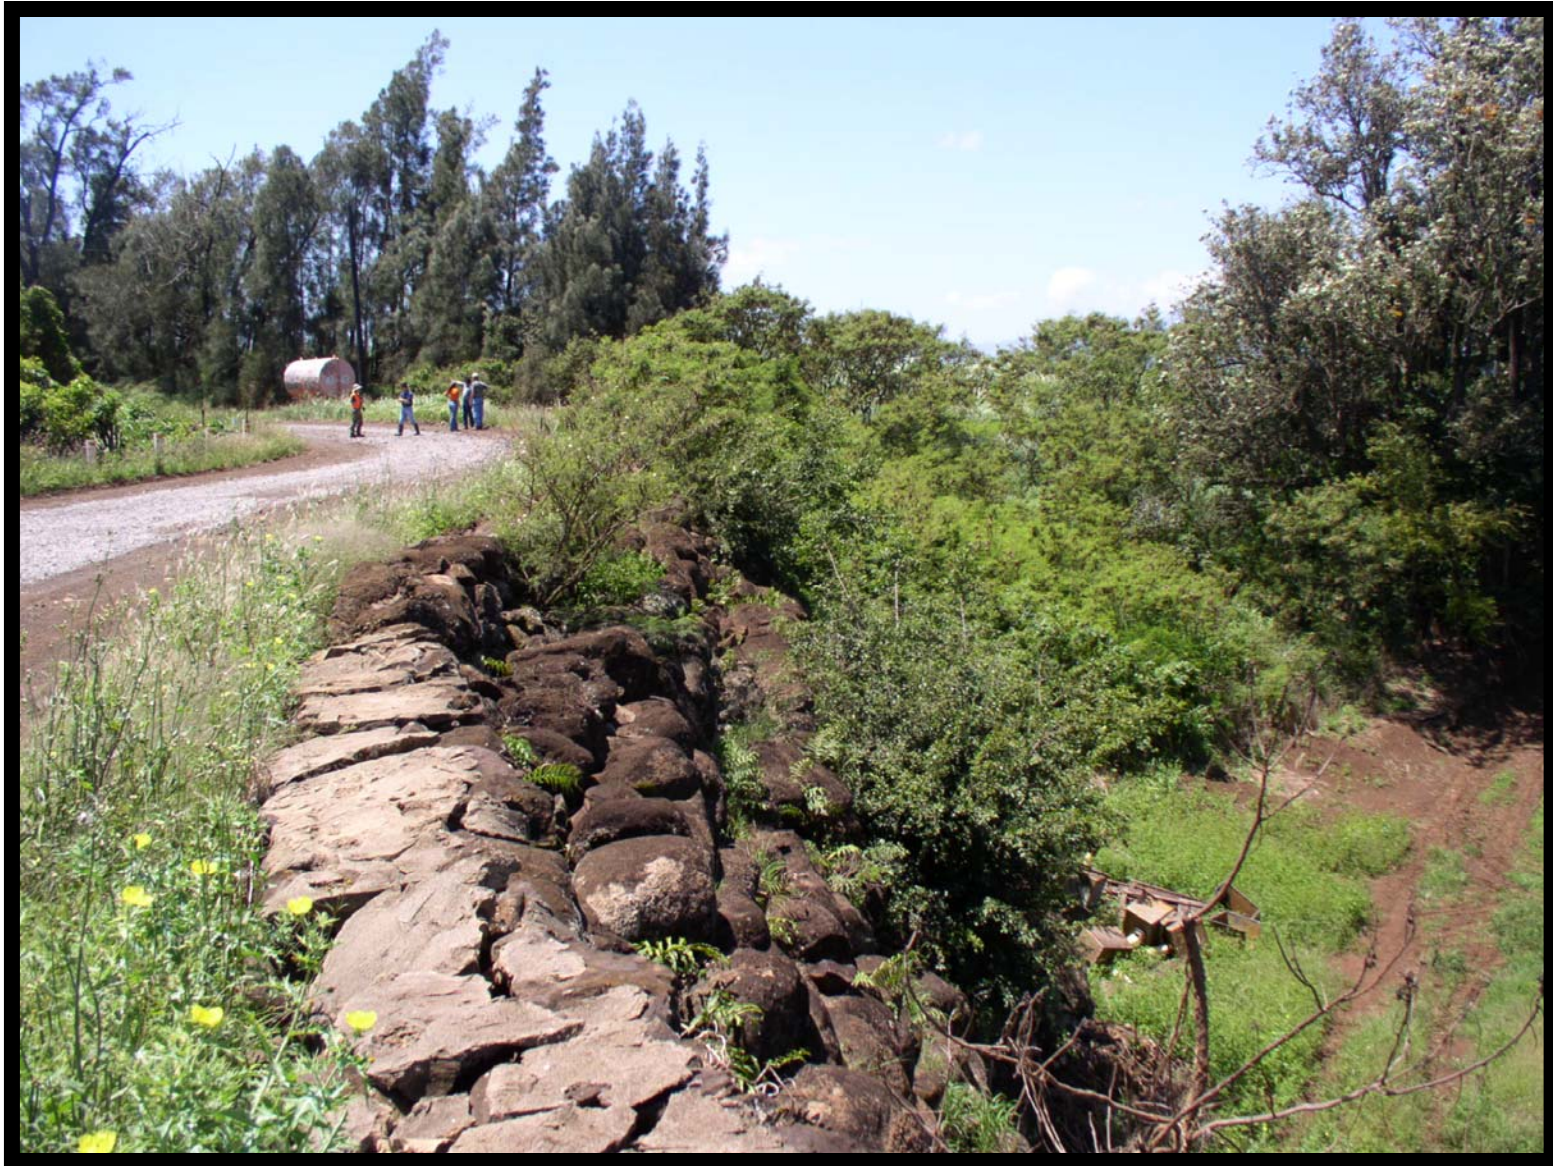
- a. The downstream slope appeared to be in fair to poor condition and requires corrective action.

- b. Slope protection needs maintenance. Need to remove trees and other vegetation from the downstream slope.
- c. The downstream slope was not visible due to high grass and bush vegetation. Clear high vegetation and maintain low to enable easy inspection.
- d. Trees were observed on the downstream slope. Trees have been identified as the probable cause of piping failures and can possibly cause severe damage to the embankment if they are uprooted during high winds. Corrective action is required to remove tree hazards from the dam. Acceptable remedies include removal of the tree and its root structure down to a 2-inch diameter and reconstructing the damaged embankment section. All repair work shall be accomplished as per the requirements of a licensed geotechnical or structural engineer. Routinely monitor the damaged area for signs of settlement and seepage.

068 Downslope - Note the trees growing out of the downstream slope, which is a rock retaining wall.

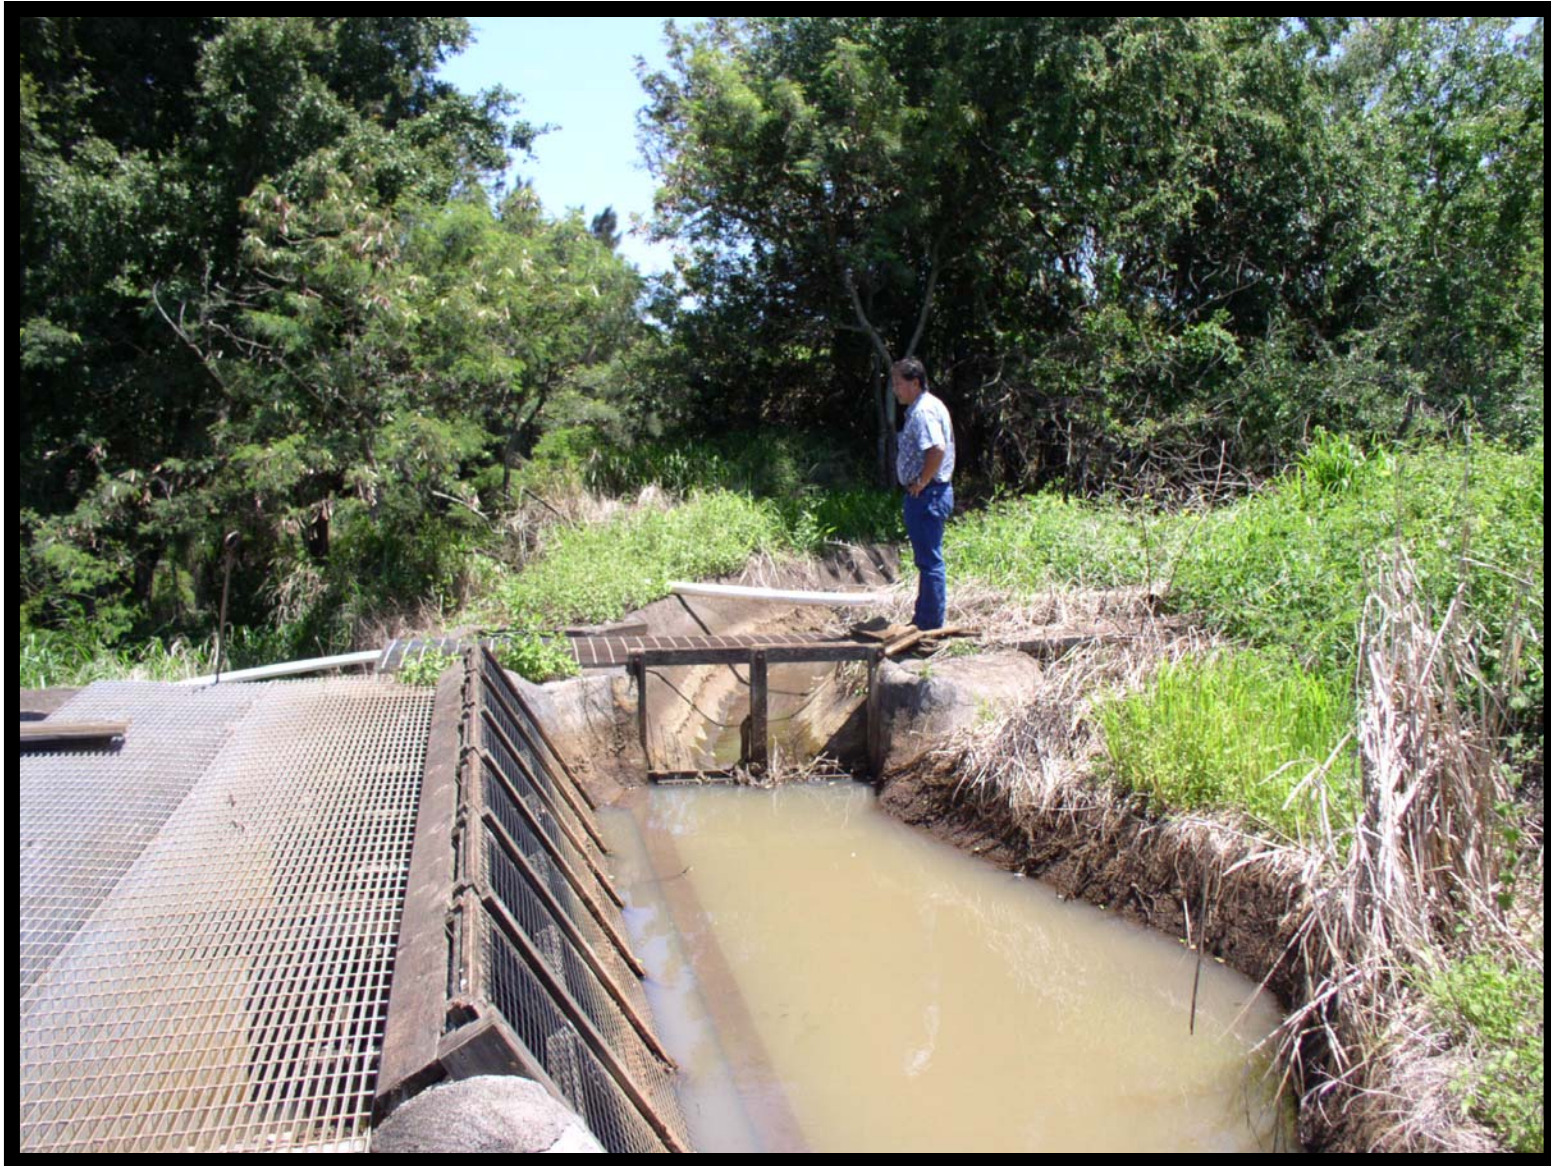
068 Out channel - The structure at the left is used to feed water to the drip fertilizing system.

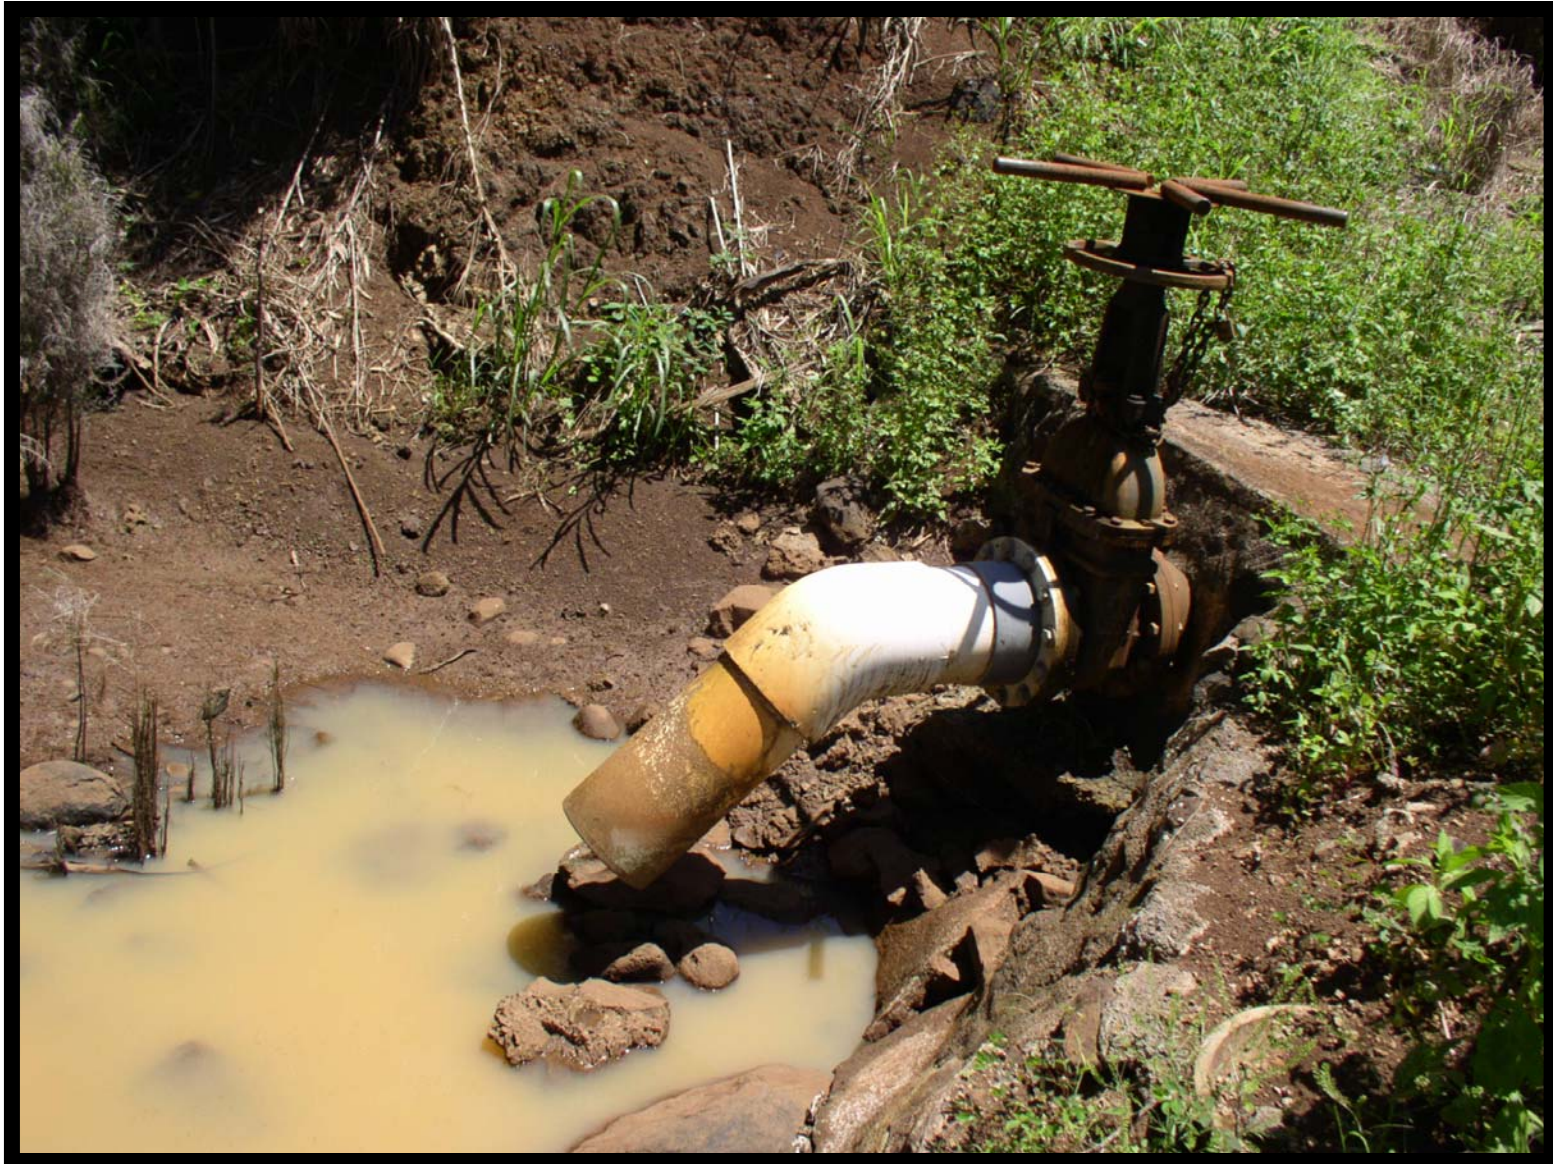
068 View of the alternate outlet for dam. It is used to supply water to the drip fertilizing system.

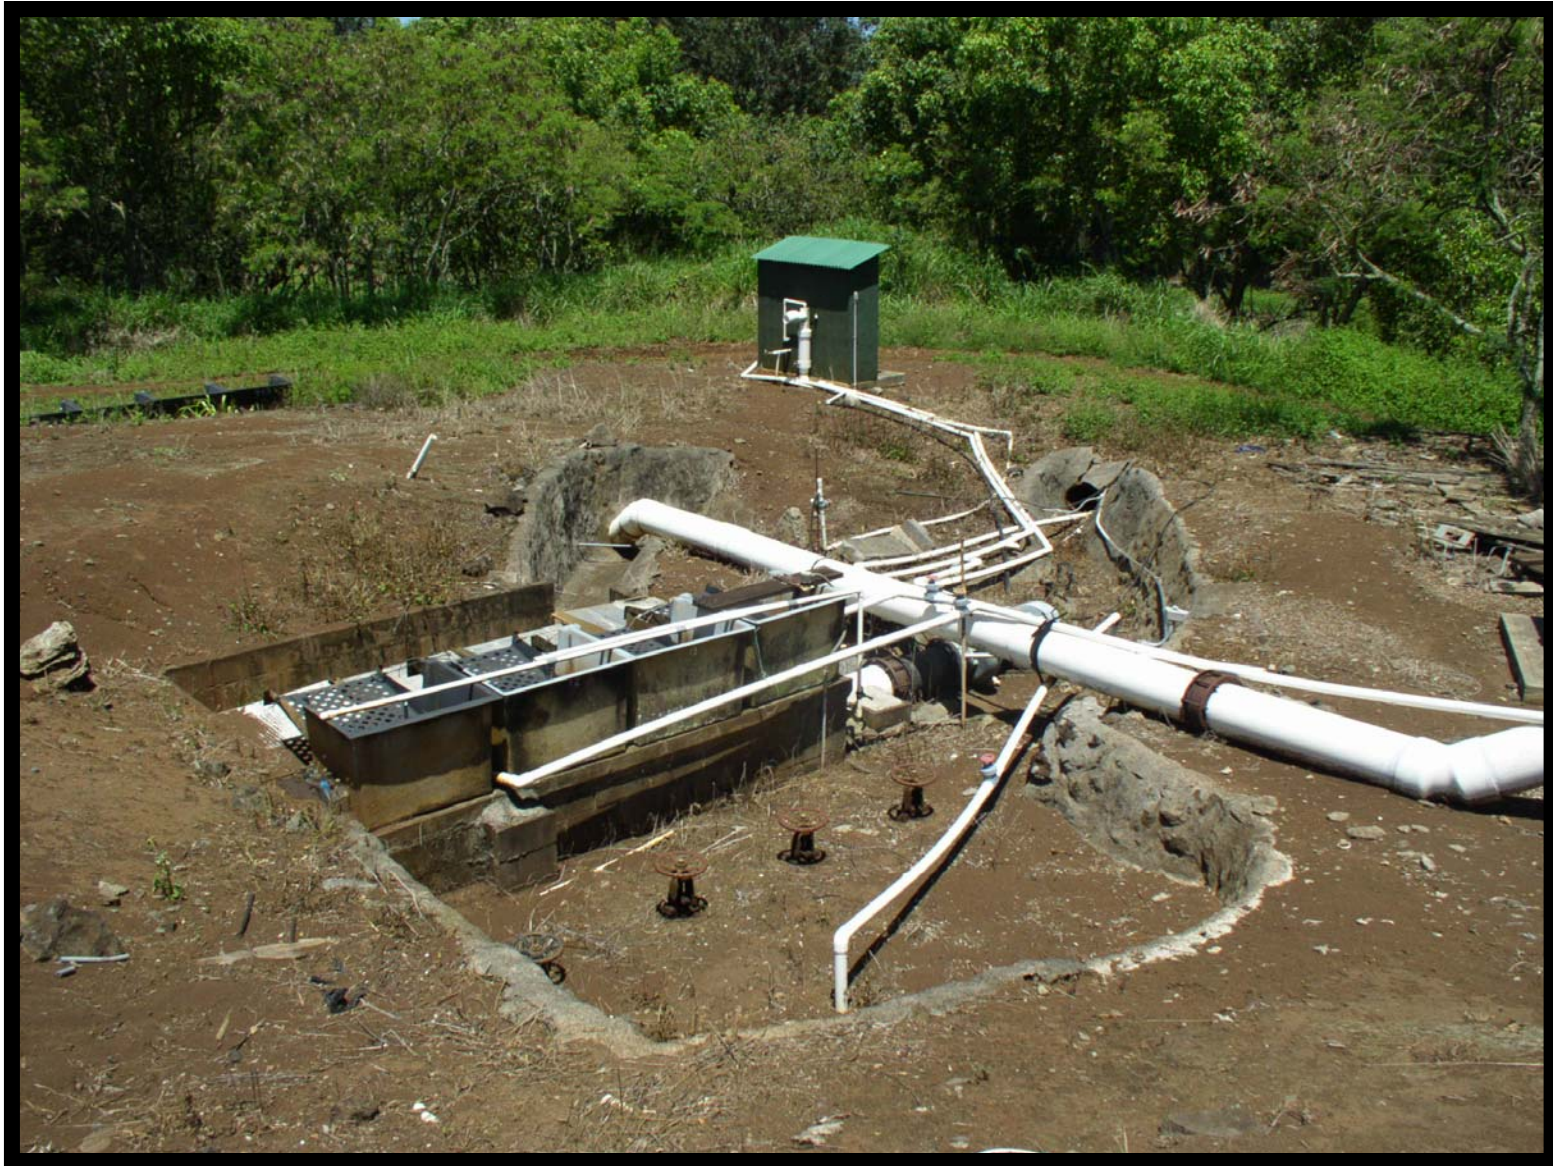
068 Outlet pipe

- a. The outlet works were not tested.
- b. The outlet works appear to be in satisfactory condition. No corrective actions are required at this time.

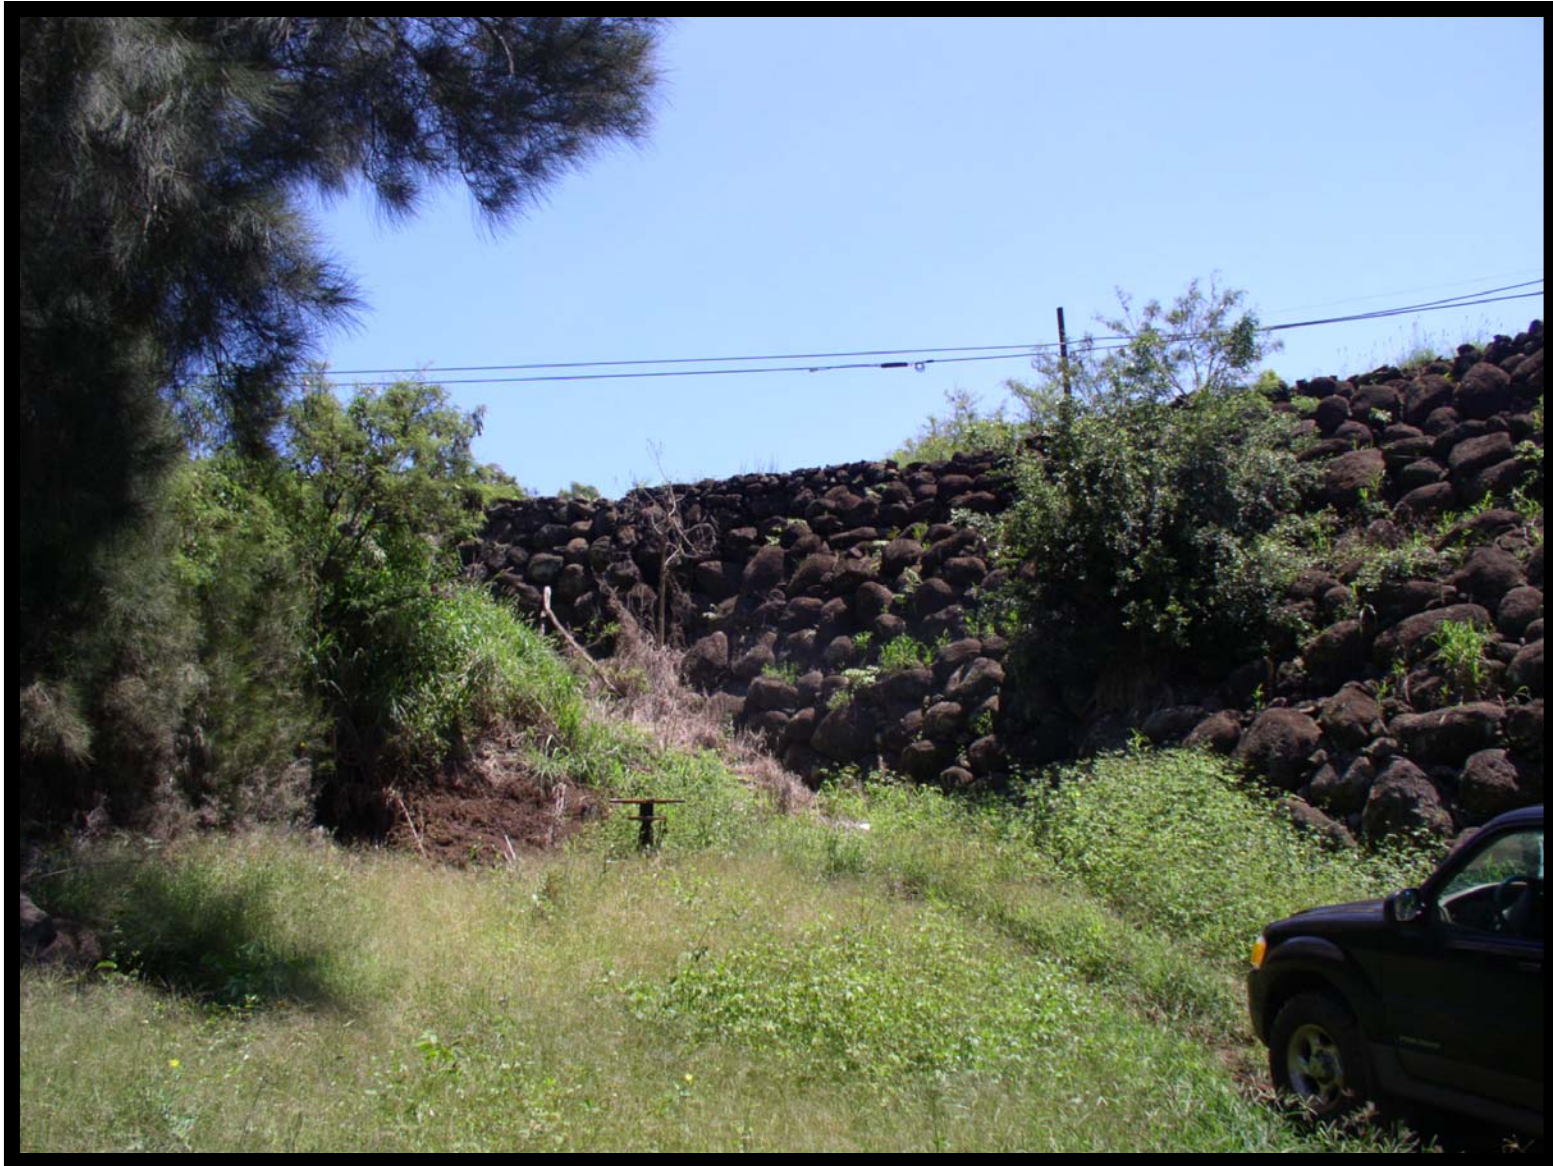
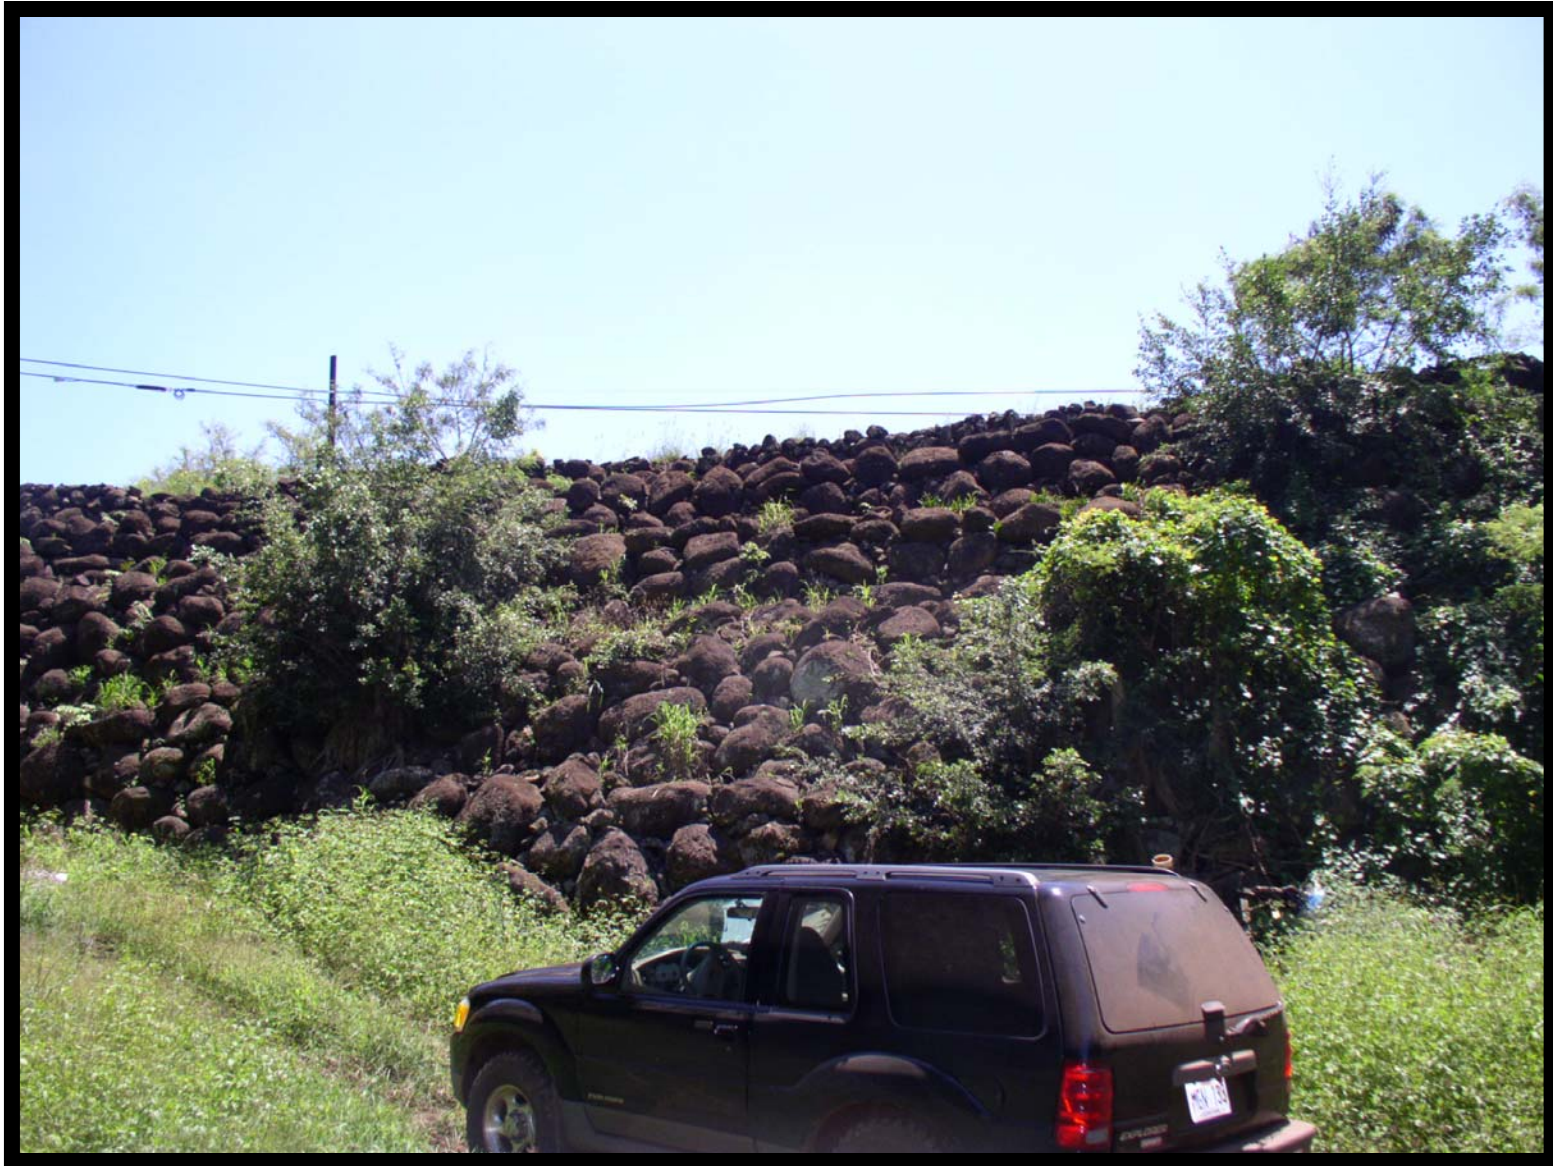
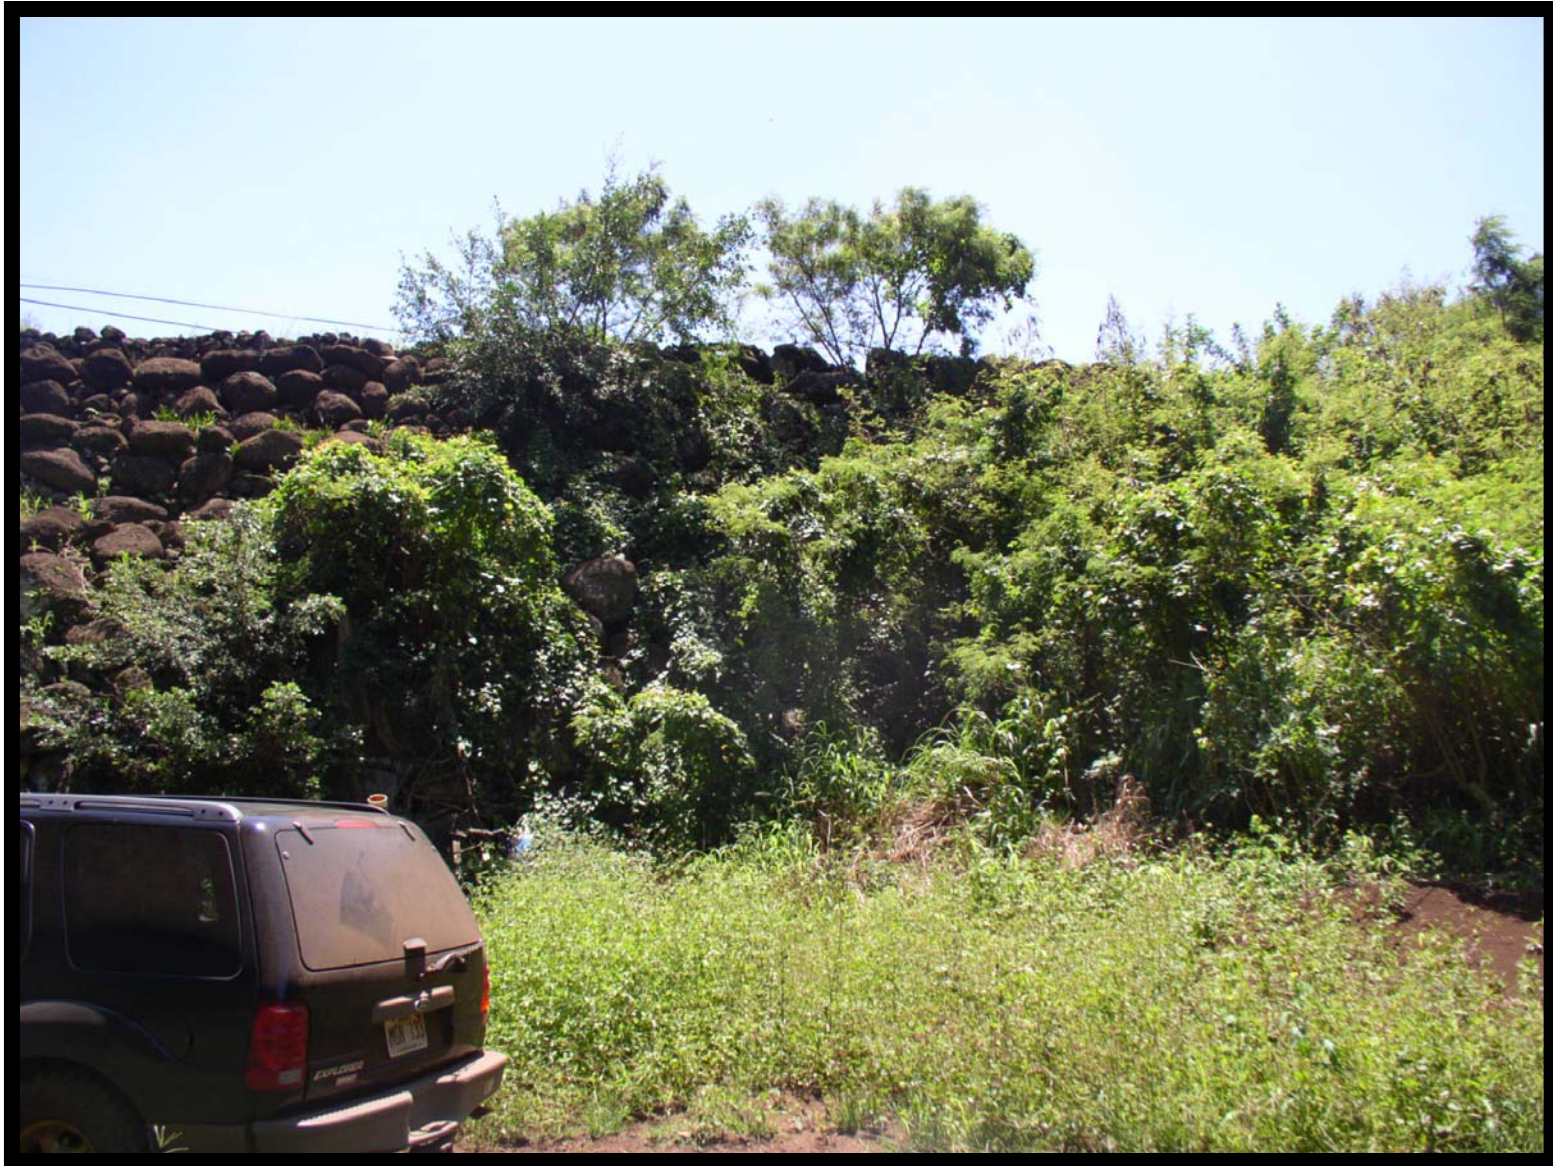
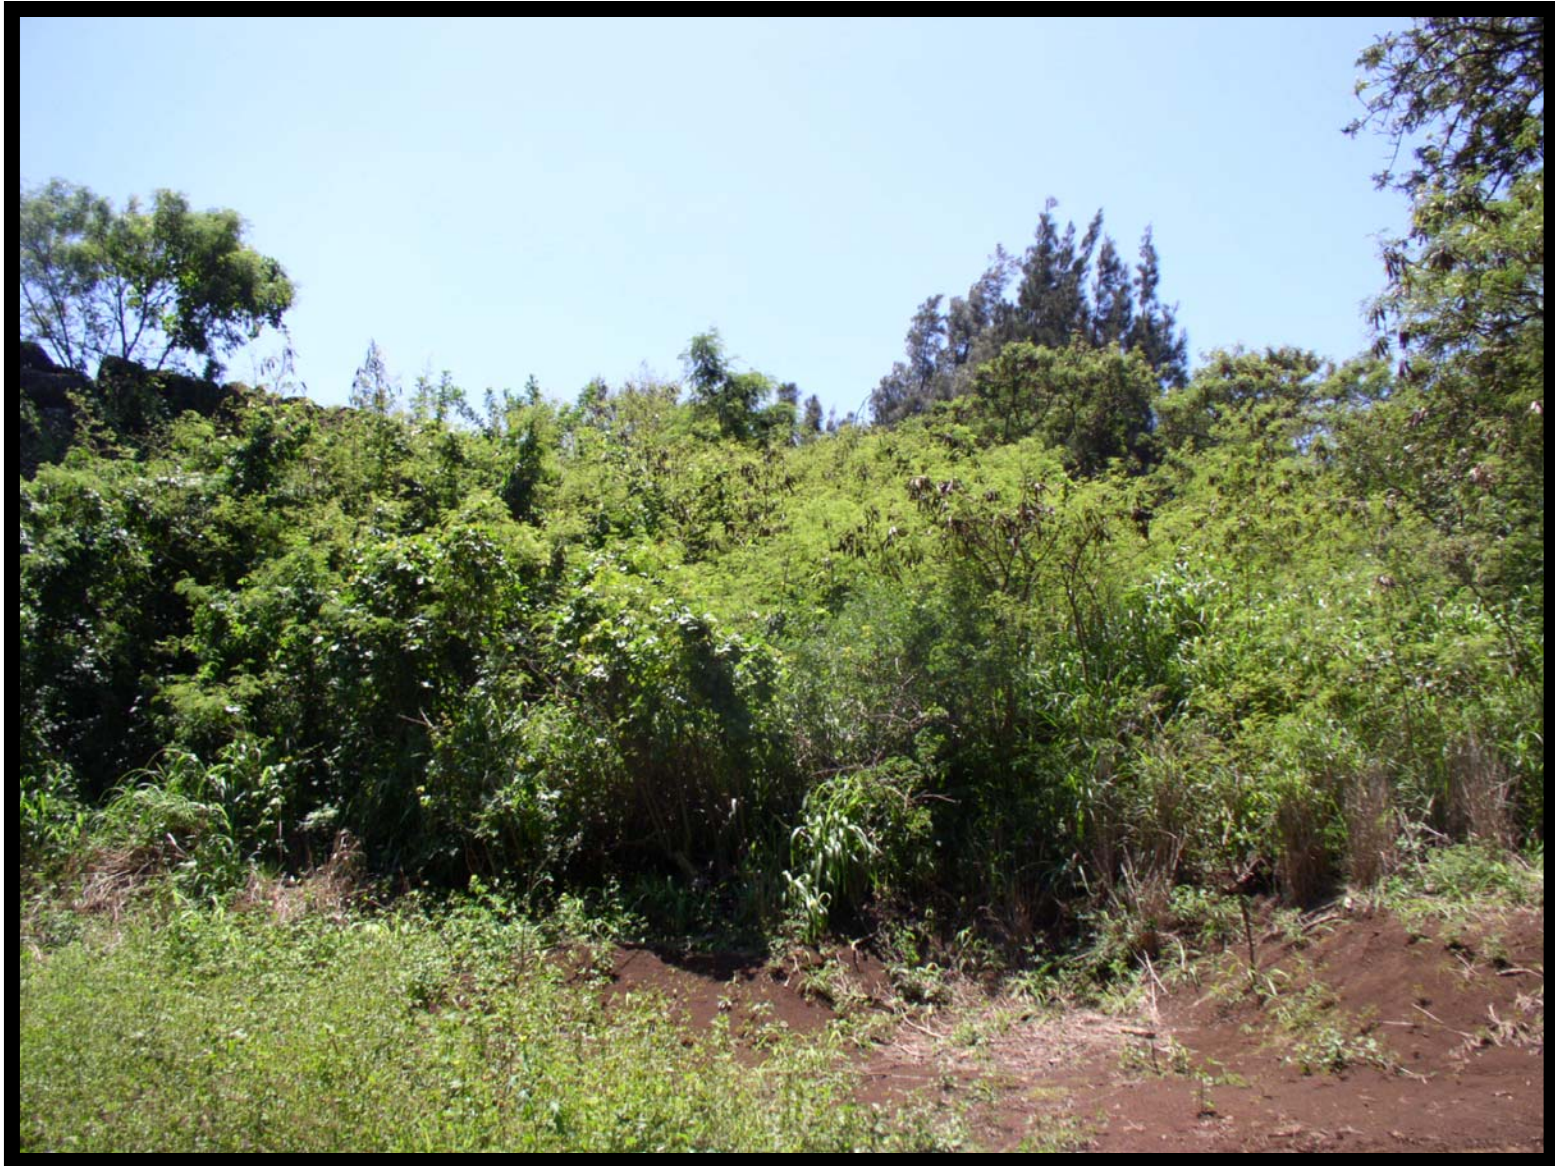
068 Panoramic view of the downstream face of the reservoir dam, looking from downstream of the dam.

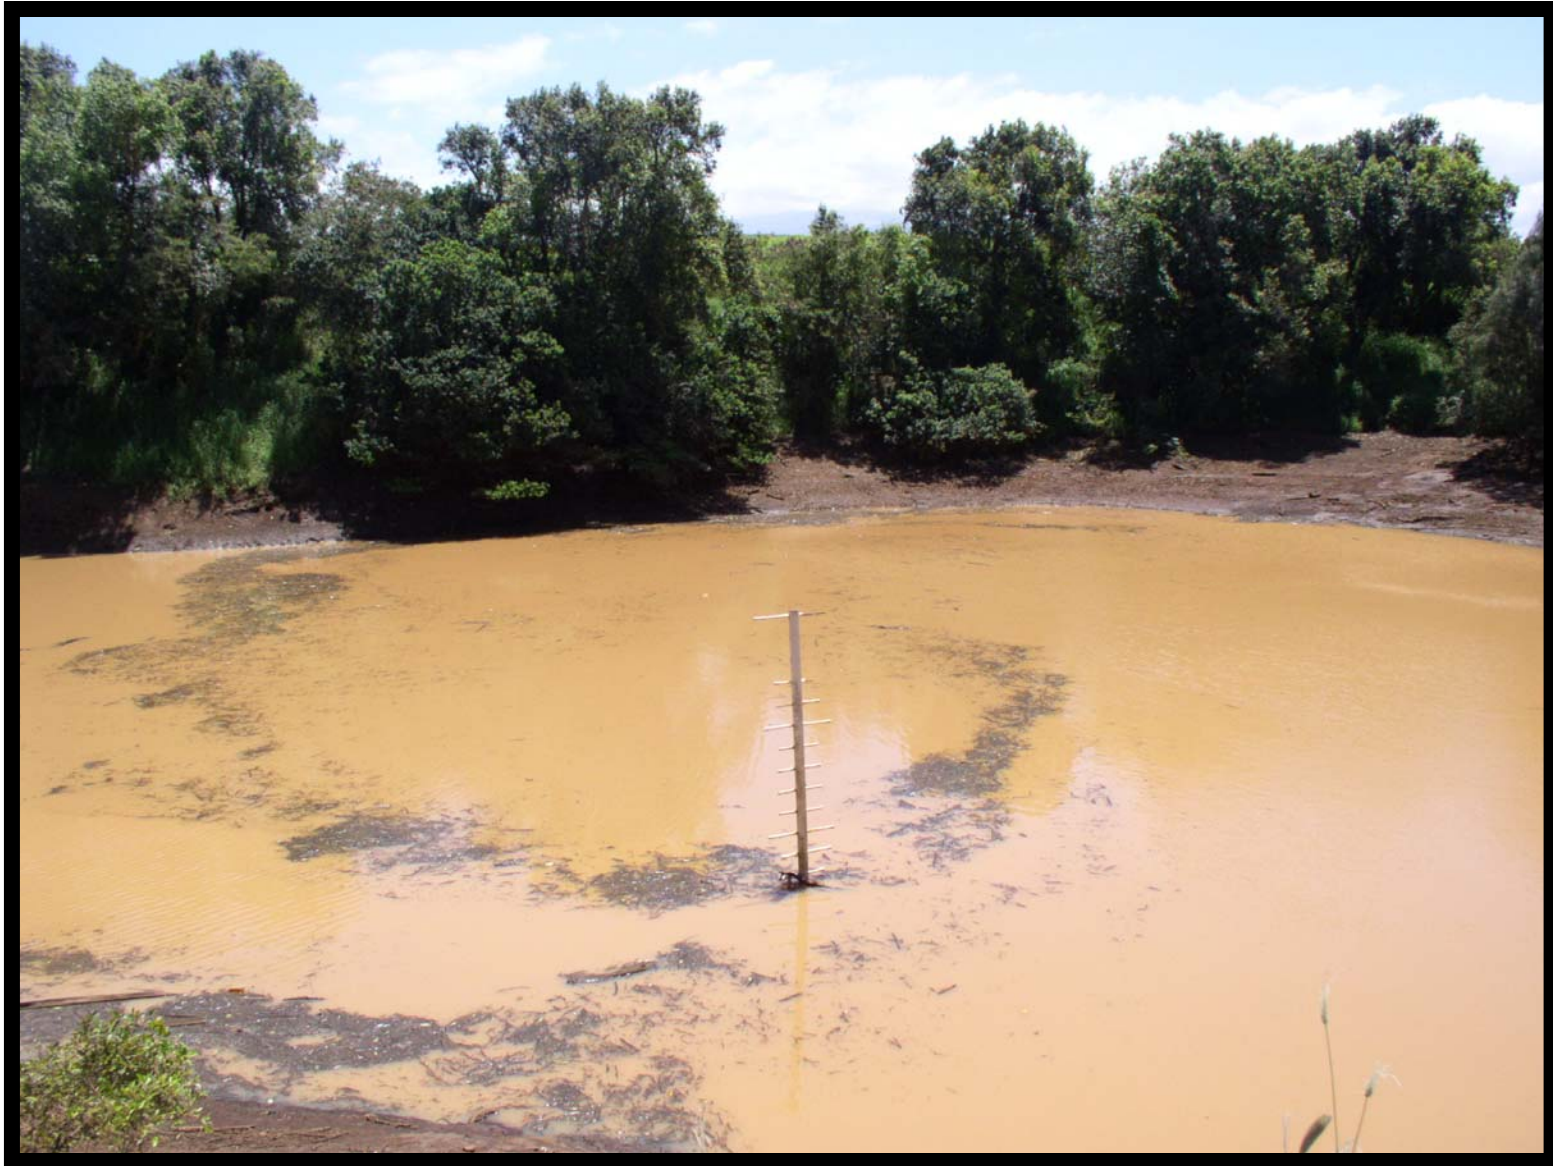
The reservoir was 7.5 feet per PVC gage at the time of inspection. The normal operating level is 7 to 18 feet per gage. A staff gage was observed in the middle of the reservoir.

- a. The reservoir appeared to be in satisfactory condition, no corrective actions are required at this time.

068 View of the reservoir. Note the gage in the center of the photo
